**Test Report For:**

**ANSI/BIFMA X5.1-2017**  
**General-Purpose Office Chairs**

**Highmark Polaris Task Chair**

Report No: OFSB - 001655  
Page: 2 of 21

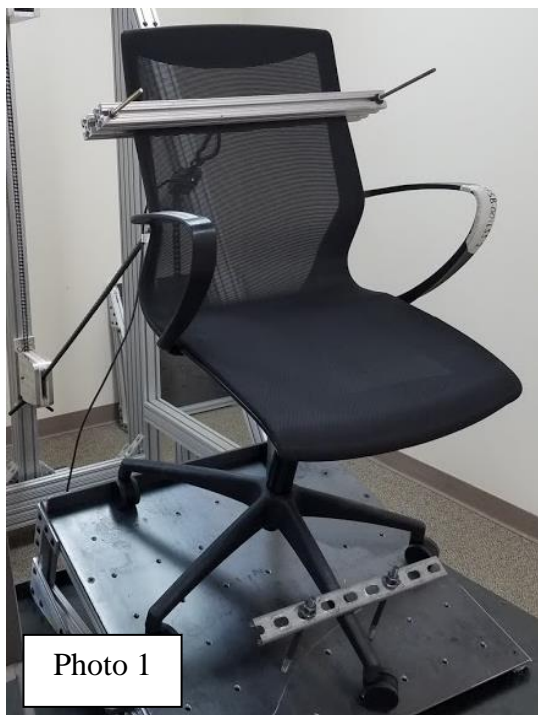
- Temperature / Humidity: 67°F / 40 RH%.
- Tilt tension: Midpoint.
- Tilt lock: Disengaged.
- Chair height: Midpoint.
- Loads were applied at a 70 degree angle to the backrest at its fully tilted position, centered 16 inches above the seat.
- Functional load: 150 lbs. for 1 minute.
- Proof load: 225 lbs. for 1 minute.
- See Photo 1 for set up.

Specimen	Load (lbs.)	Time (sec.)	Observation
2	150	60	No loss of serviceability.
	225	60	No sudden and major change in structural integrity of chair.

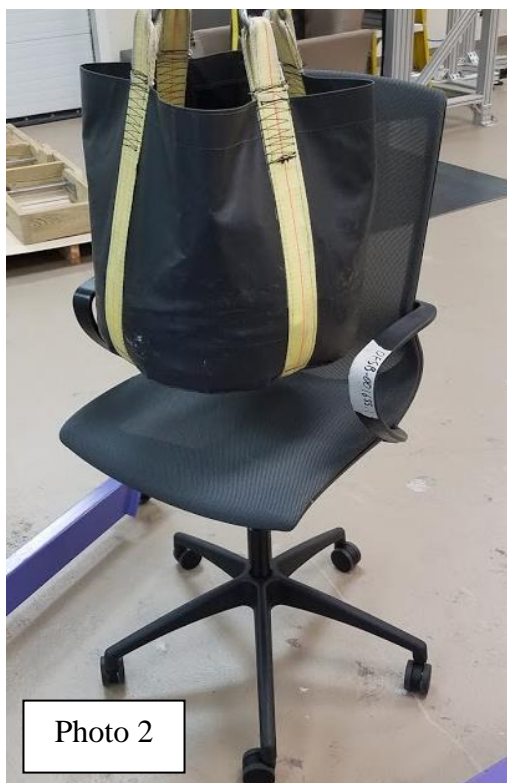
Photo 2

- Temperature / Humidity: 68°F / 39 RH%.
- Tilt tension: Midpoint.
- Load dropped from a height of 6 inches through a 16 inch diameter bag.
- Functional load: 225 lbs.
- Proof load: 300 lbs.
- See Photos 2 & 3 for set up.

Specimen	Chair Height	Load (lbs.)	Observation
1	Maximum	225	No loss of serviceability.
	Maximum	300	No sudden and major change in structural integrity of chair.
	Minimum	225	No loss of serviceability.
	Minimum	300	No sudden and major change in structural integrity of chair.

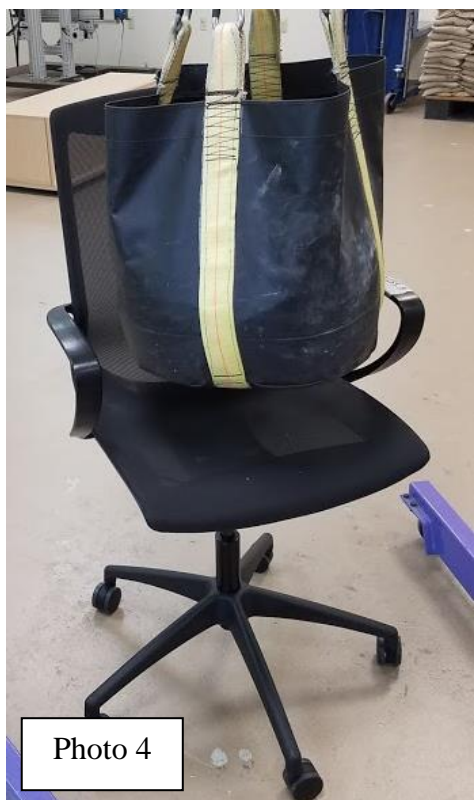
Photo 4

- Temperature / Humidity: 70°F / 39 RH%.
- Tilt tension: Midpoint.
- Load dropped from a height of 6 inches through a 16 inch diameter bag.
- Functional load: 225 lbs.
- Proof load: 300 lbs.
- See Photos 4 & 5 for set up.

Specimen	Chair Height	Load (lbs.)	Observation
8b	Maximum	225	No loss of serviceability.
	Maximum	300	No sudden and major change in structural integrity of chair.
	Minimum	225	No loss of serviceability.
	Minimum	300	No sudden and major change in structural integrity of chair.

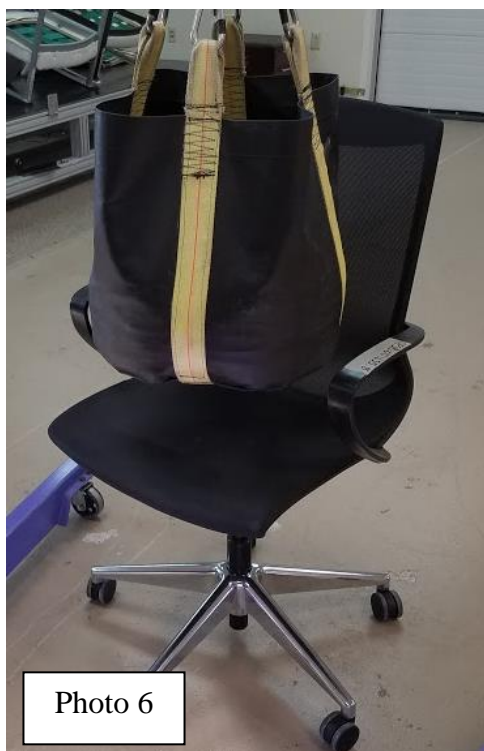
Photo 6

- Temperature / Humidity: 69°F / 42 RH%.
- Tilt tension: Midpoint.
- Load dropped from a height of 6 inches through a 16 inch diameter bag.
- Functional load: 225 lbs.
- Proof load: 300 lbs.
- See Photos 6 & 7 for set up.

Specimen	Chair Height	Load (lbs.)	Observation
10a	Maximum	225	No loss of serviceability.
	Maximum	300	No sudden and major change in structural integrity of chair.
	Minimum	225	No loss of serviceability.
	Minimum	300	No sudden and major change in structural integrity of chair.

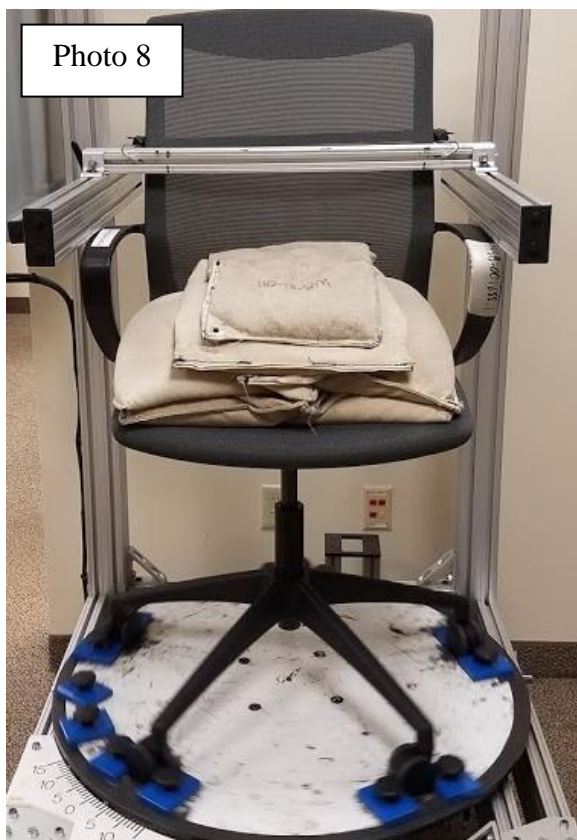
Photo 8

- Temperature / Humidity: 68 - 71°F / 38 - 52 RH%.
- Tilt tension: Midpoint.
- The base was cycled 360 degrees with 270 lbs. loaded on the seat, 2 inches in front of the spindle. The chair was cycled in both the maximum and minimum seat height settings.
- Test rate: 13 cpm.
- See Photos 8 & 9 for set up.

Specimen	Chair Height	Cycles	Observation
1	Maximum	0	Test began at the highest position.
		60,000	No loss of serviceability.
	Minimum	60,000	Test continued at the lowest position.
		120,000	No loss of serviceability.

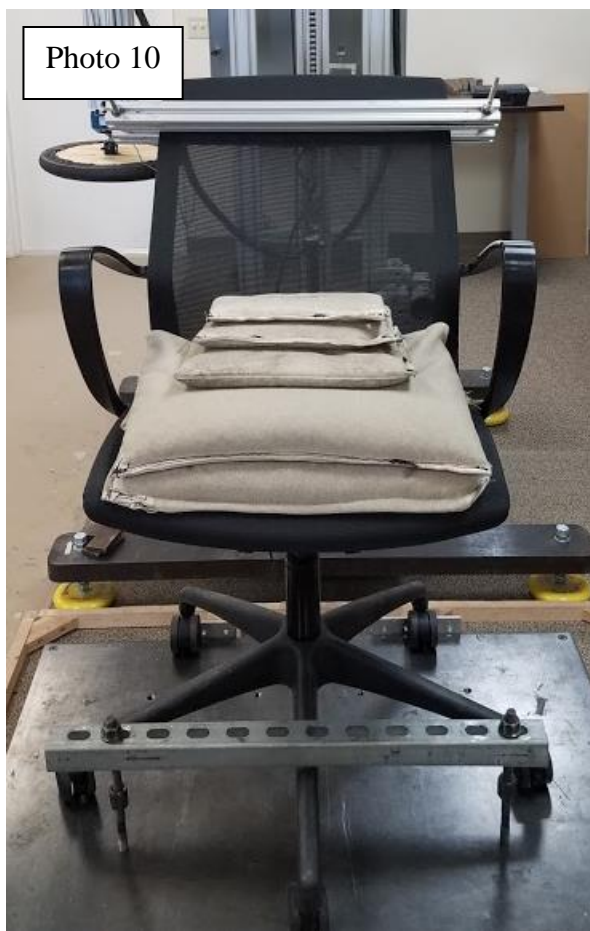
- Temperature / Humidity: 68 - 70°F / 37 - 52 RH%.
- Tilt tension: Midpoint.
- Chair height: Midpoint.
- The tilt mechanism was cycled from all the way forward to all the way rearward and back while 240 lbs. was resting in the seat.
- Test rate: 19 - 20 cpm.
- See Photo 10 for set up.

Specimen	Load (lbs.)	Observation
7	0	Test began.
	300,000	No loss of serviceability, tilt mechanism still functional.

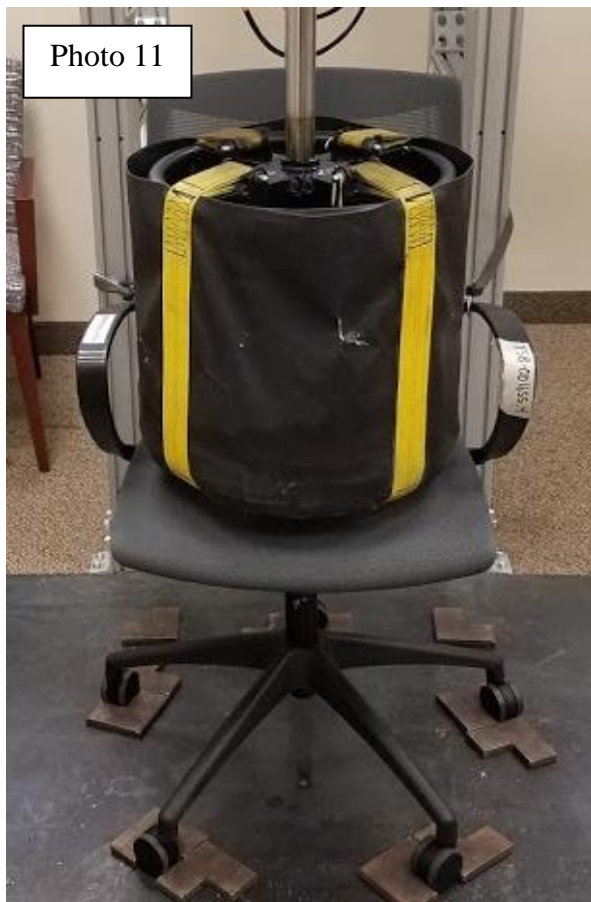
- Temperature / Humidity: 68 - 71°F / 38 - 52 RH%.
- A 125 lb. load was dropped through a 16 in. diameter bag from 1.4 in. above uncompressed seat surface. The bag was placed 0.5 inches forward the backrest and centered side to side.
- Test rate: 24 - 27 cpm.
- See Photo 11 for set up.

Specimen	Load (lbs.)	Cycles	Observation
4	125	0	Test began.
	125	100,000	No loss of serviceability.

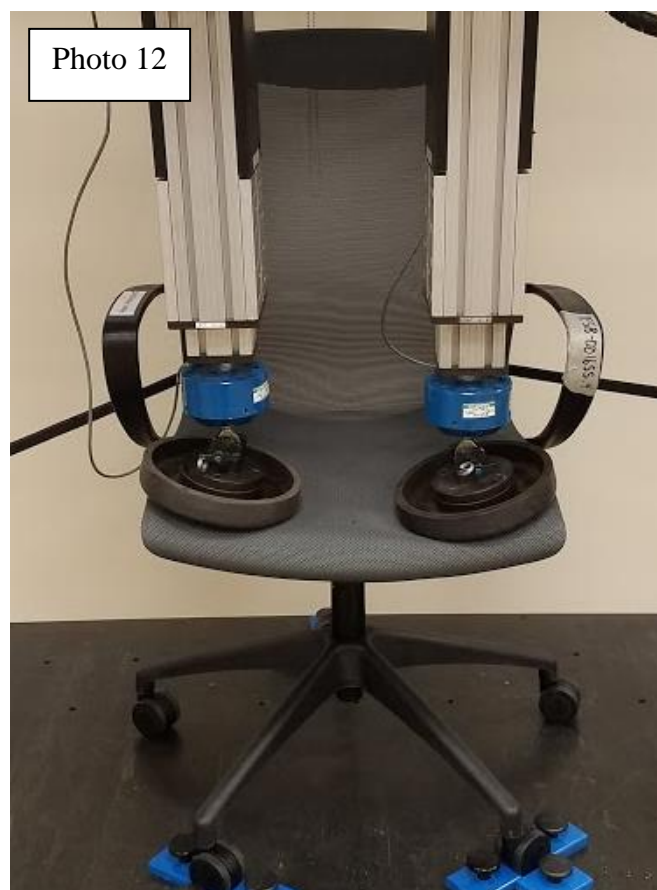
- Temperature / Humidity: 70 - 71°F / 38 - 42 RH%.
- Two 200 lb. loads were applied alternately through 8 inch load pads positioned at the front corners of the seat, flush with the load bearing surface to the front and sides.
- Test rate: 11 - 12 cpm.
- See Photo 12 for set up.

Specimen	Load (lbs.)	Cycles	Observation
4	200	0	Test began.
	200	20,000	No loss of serviceability.

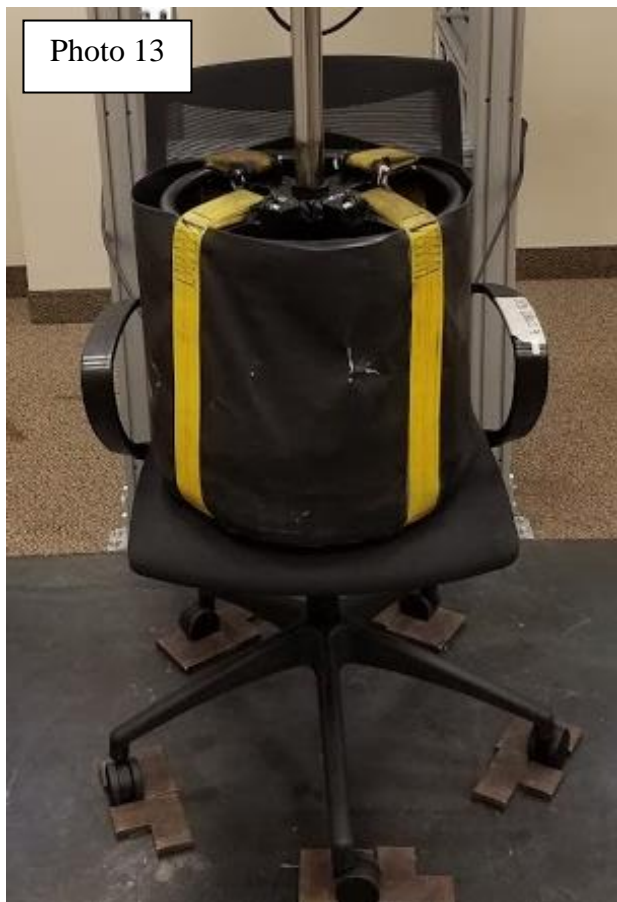
- Temperature / Humidity: 69 - 70°F / 37 - 52 RH%.
- A 125 lb. load was dropped through a 16 in. diameter bag from 1.4 in. above uncompressed seat surface. The bag was placed 0.5 inches forward the backrest and centered side to side.
- Test rate: 22 - 24 cpm.
- See Photo 13 for set up.

Specimen	Load (lbs.)	Cycles	Observation
9	125	0	Test began.
	125	100,000	No loss of serviceability.

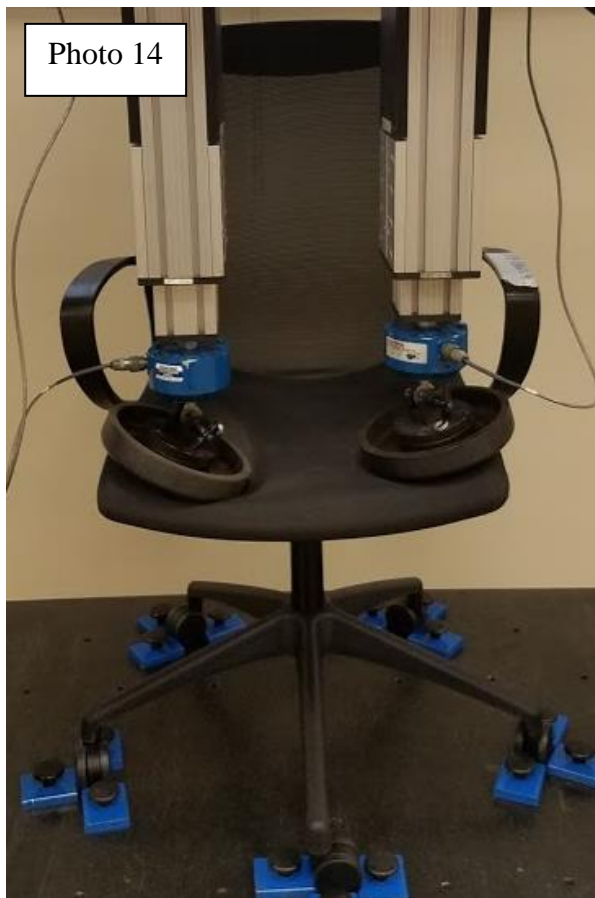
- Temperature / Humidity: 69°F / 41 - 43 RH%.
- Two 200 lb. loads were applied alternately through 8 inch load pads positioned at the front corners of the seat, flush with the load bearing surface to the front and sides.
- Test rate: 18 - 19 cpm.
- See Photo 14 for set up.

<u>Specimen</u>	<u>Load (lbs.)</u>	<u>Cycles</u>	<u>Observation</u>
9	200	0	Test began.
	200	20,000	No loss of serviceability.

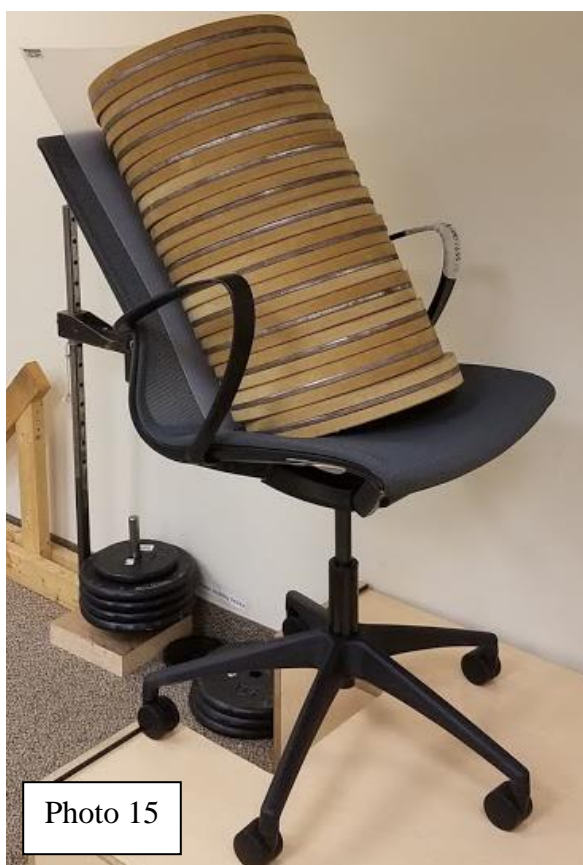
Photo 15

- Temperature / Humidity: 68°F / 40 RH%.
- Type III rear stability performed with 6 discs in seat, force applied to front of top disc, tilt lock fully engaged in upright position.
- Type III rear stability force: 1.1 (47 – H). The load shall not be less than 20.9 lbs.
- Type I rear stability performed with 13 discs in seat, tilt lock disengaged.
- Seat height (H): 23.75 inches.
- See Photos 15 & 16 for set up.

Specimen	Direction	Required Force (lbs.)	Achieved Force (lbs.)	Observation
1	Rear Type III	25.9	> 25.9	The chair did not tip over.
	Rear Type I	NA	NA	The chair did not tip over.

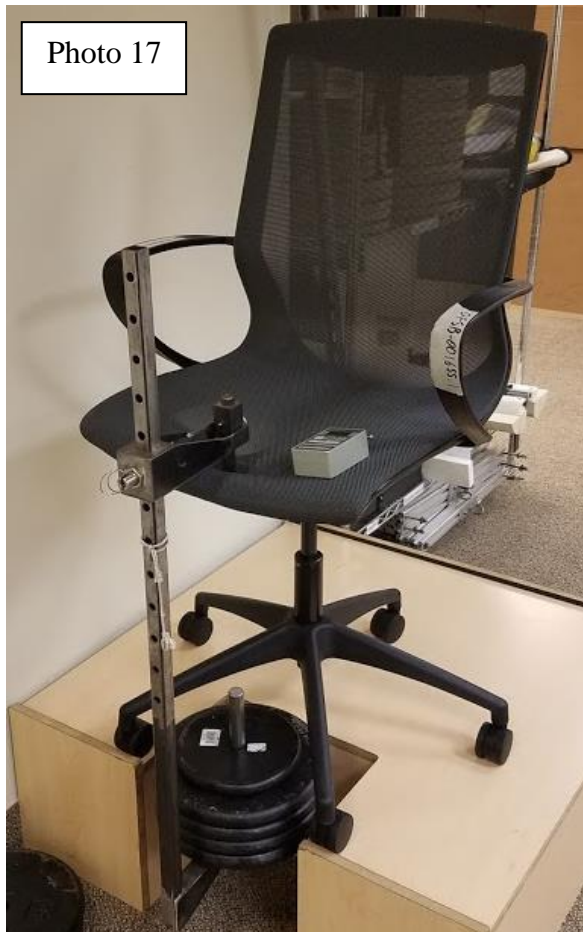
- Temperature / Humidity: 68°F / 40 RH%.
- Vertical force: 135 lbs. was hung 2.4 in. back from the front of the seat pan.
- Horizontal force: 4.5 lbs. level with seat pan.
- See Photo 17 for set up.

<u>Specimen</u>	<u>Direction</u>	<u>Required Force (lbs.)</u>	<u>Achieved Force (lbs.)</u>	<u>Observation</u>
1	Front	4.5	> 4.5	The chair did not tip over.

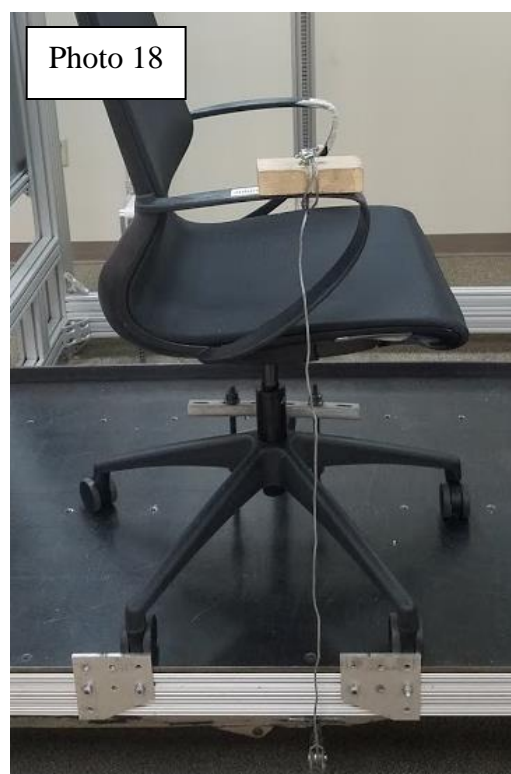
- Temperature / Humidity: 71°F / 38 RH%.
- Loads were applied using a 5 inch adapter positioned at the weakest position of the armrest.
- Functional load: 169 lbs. held for 1 minute.
- Proof load: 253 lbs. held for 15 seconds.
- See Photo 18 for set up.

Specimen	Load (lbs.)	Time (sec.)	Observation
6	169	60	No loss of serviceability.
	253	15	No sudden and major change to the chair.

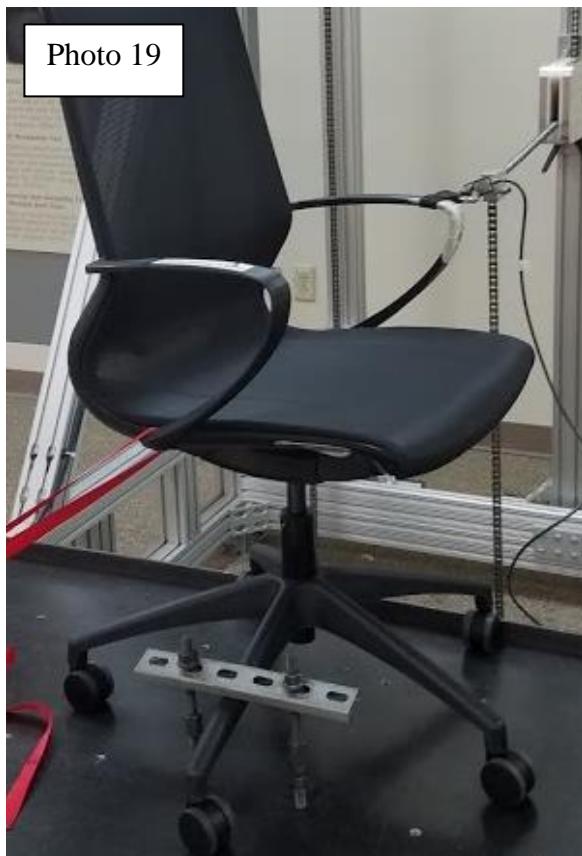
- Temperature / Humidity: 71°F / 38 RH%.
- Loads were applied at the weakest position of the armrest.
- Functional load: 100 lbs. held for 1 minute.
- Proof load: 150 lbs. held for 15 seconds.
- See Photo 19 for set up.

Specimen	Load (lbs.)	Time (sec.)	Observation
6	100	60	No loss of serviceability.
	150	15	No sudden and major change to the chair.

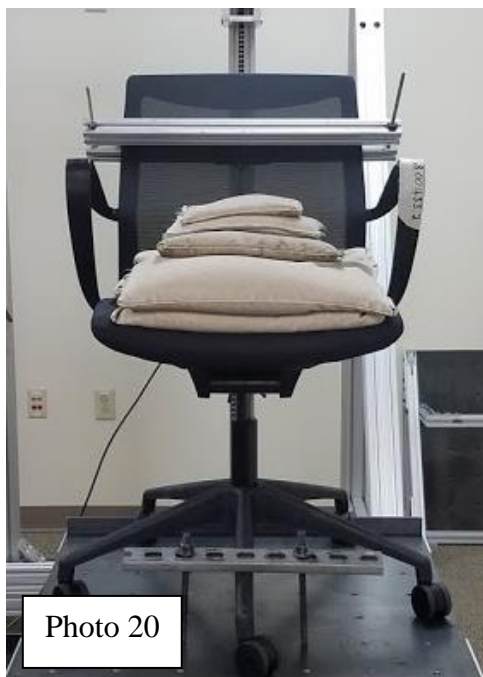
Photo 20

- Temperature / Humidity: 70 - 71°F / 38 - 52 RH%.
- Tilt tension: Midpoint.
- Chair height: Midpoint.
- Tilt lock: disengaged.
- A 100 lb. force was applied at the specified location of the backrest at a 90 degree angle to the backrest, 16 inches above the seat. A 240 lb. load was placed in the seat.
- 80,000 cycles at the center of the back, 20,000 cycles 4" left of center, and 20,000 cycles 4" right of center.
- Test rate: 22 - 25 cpm.
- See Photos 20 & 21 for set up.

Specimen	Segment	Cycles	Observation
2	Center	0	Test began at the center on the backrest.
		80,000	No loss of serviceability.
	4" left	80,000	Test continued offset to the left on the backrest.
		100,000	No loss of serviceability.
	4" right	100,000	Test continued offset to the right on the backrest.
		120,000	No loss of serviceability.

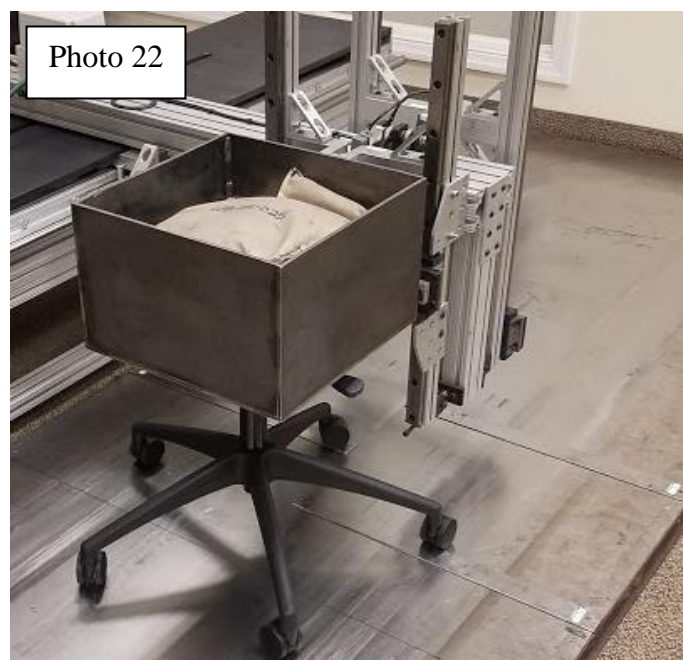
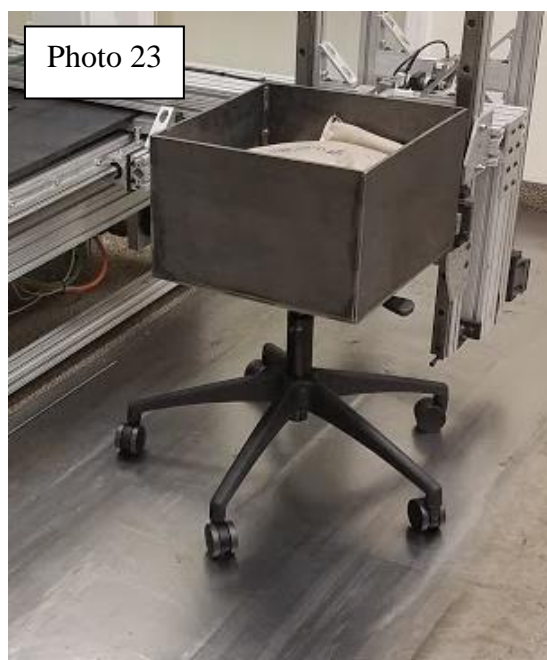
- Temperature / Humidity: 69 - 71°F / 38 - 52 RH%.
- The casters are required to carry the weight of the chair plus 270 lbs.
- The specimen was cycled over three 0.125" obstacles for 2,000 cycles. The obstacles were then removed and the chair was cycled over a smooth surface for the duration of the test. After the cycles were complete, each caster was subjected to a 5 lb. caster retention test.
- Test rate: 8 - 9 cpm.
- See Photos 22 & 23 for set up.

Specimen	Segment	Cycles	Observation
3	Obstacles	0	Test began over obstacles.
		2,000	No changes.
	Smooth Surface	2,000	Test continued over smooth surface.
		100,000	No loss of serviceability.
	Pull Force	N/A	Each caster exceeded the 5 lb. caster retention requirement.

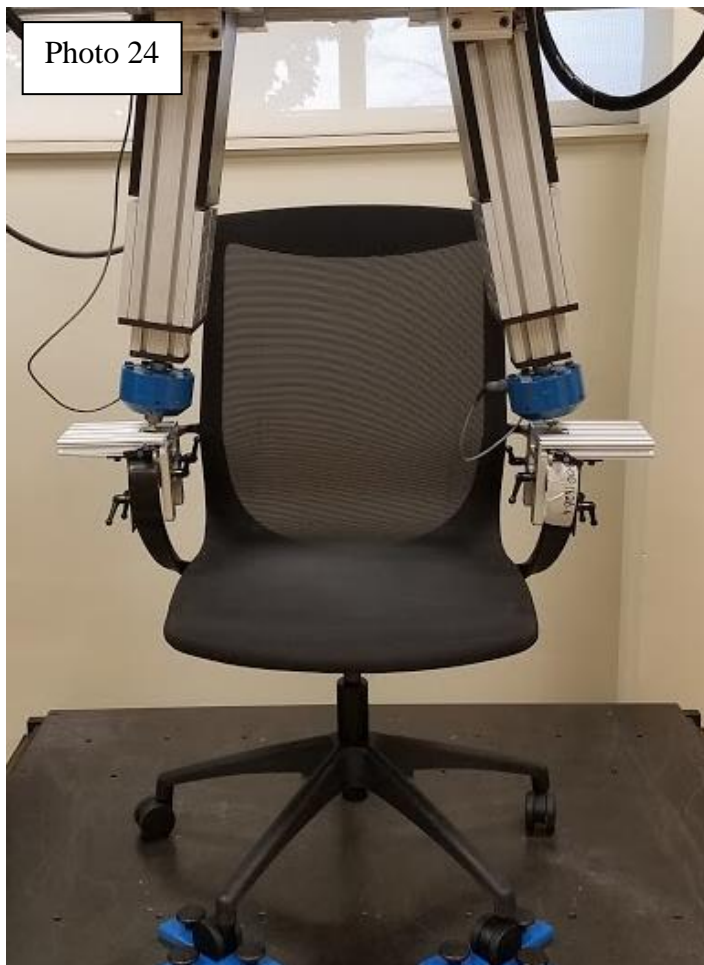
- Temperature / Humidity: 71°F / 46 - 52 RH%.
- A force of 90 lbs. was applied to each arm simultaneously at an initial 10° to the arm through a 4 inch loading device.
- Test rate: 22 - 24 cpm.
- See Photo 24 for set up.

Specimen	Force (lbs.)	Cycles	Observation
6	90	0	Test began.
	90	60,000	No loss of serviceability.

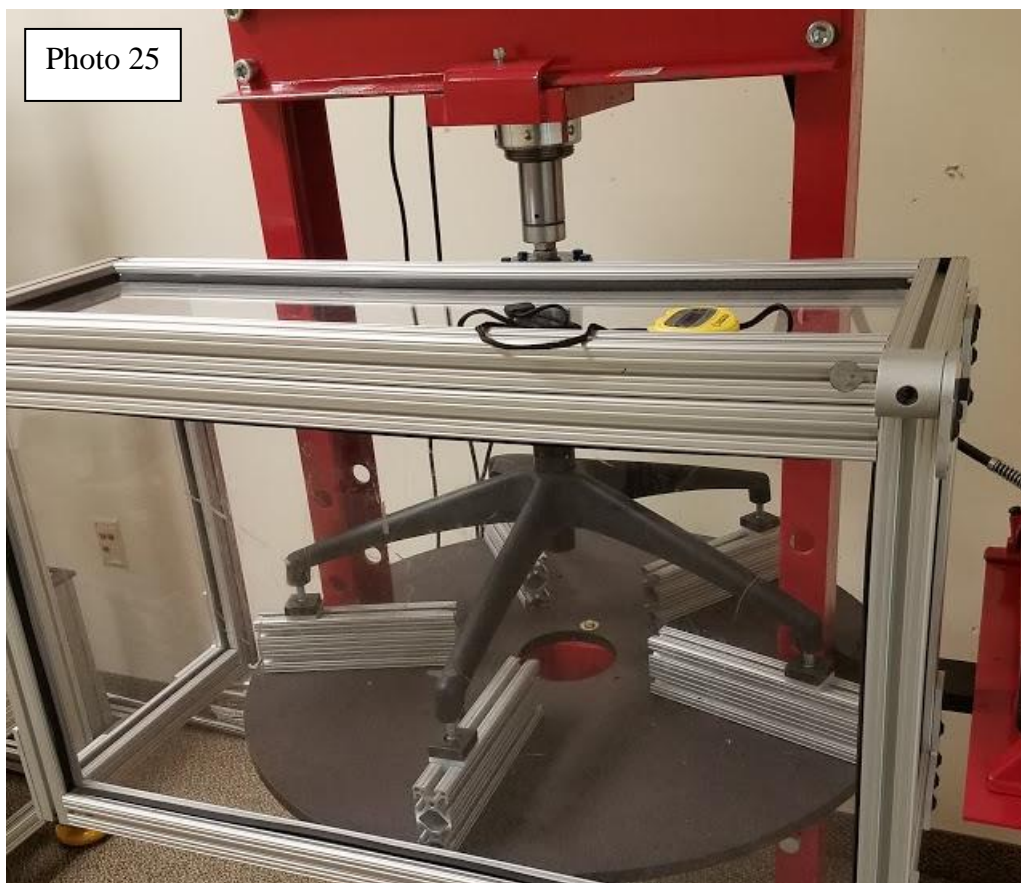
- Temperature / Humidity: 70°F / 40 RH%.
- Casters were removed from stems; each stems was then inserted into the base.
- 2,500 lbs of force was applied for 1 minute, then released.
- 2,500 lbs of force was applied a second time for an additional minute, then released.
- See Photo 25 for set up.

<u>Specimen</u>	<u>Load (lbs.)</u>	<u>Time (sec.)</u>	<u>Observation</u>
6	2,500	60	No sudden and major change in structural integrity.
	2,500	60	No sudden and major change in structural integrity.

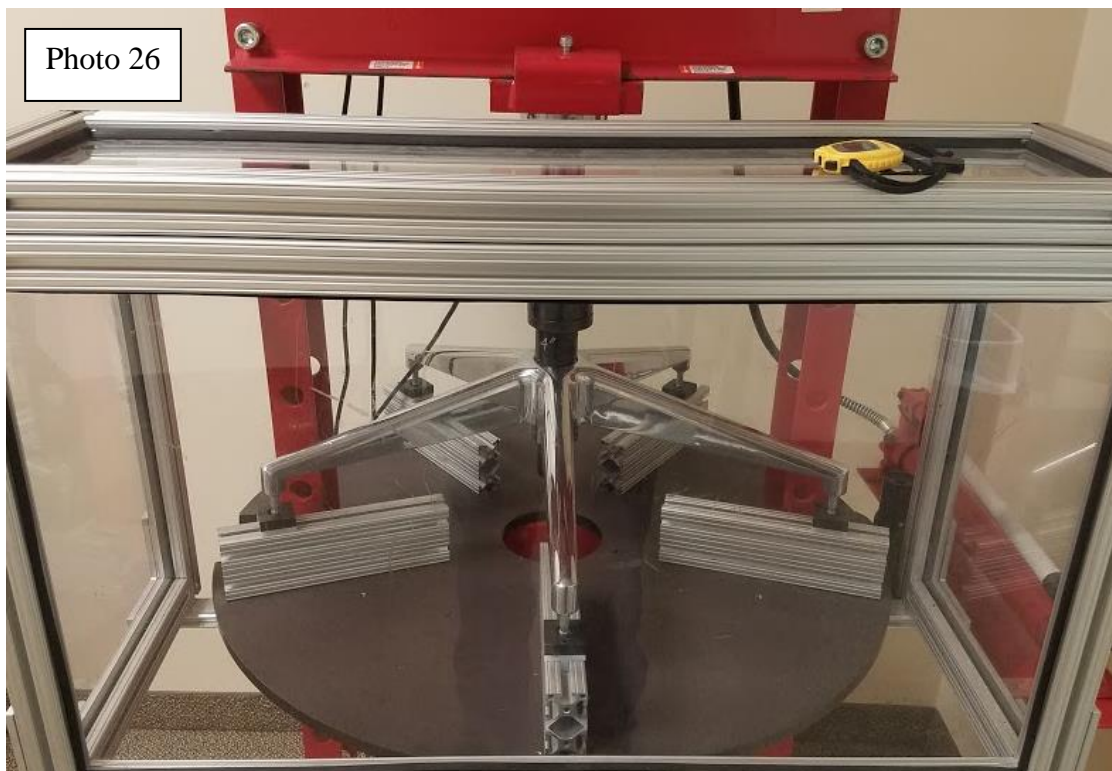
- Temperature / Humidity: 70°F / 42 RH%.
- Casters were removed from stems; each stems was then inserted into the base.
- 2,500 lbs of force was applied for 1 minute, then released.
- 2,500 lbs of force was applied a second time for an additional minute, then released.
- See Photo 26 for set up.

Specimen	Load (lbs.)	Time (sec.)	Observation
10b	2,500	60	No sudden and major change in structural integrity.
	2,500	60	No sudden and major change in structural integrity.
